Additional Investigations Report - Building Envelope

**Trinity Place, 2490 W 2nd Avenue
Vancouver, BC**

011778-A0

2011.09.29

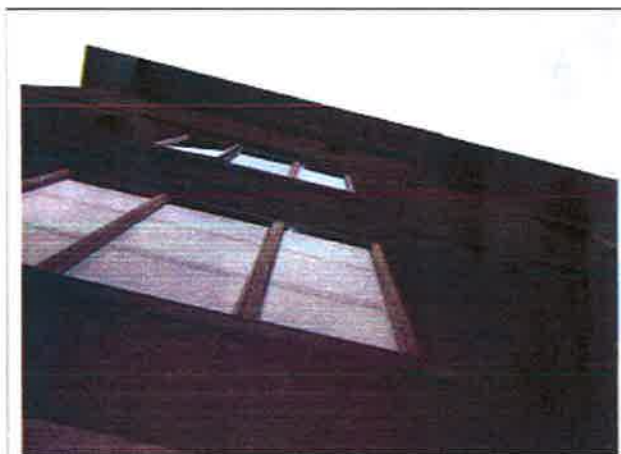
- o The moisture content readings on this wall at the reviewed locations had readings higher than 19% Moisture Content (MC) readings, at 3 (readings of 21.4%, 25.2% and 29.6%) out of 8 probed locations. The readings were particularly higher at the window sill locations. Readings higher than 19% indicate possible moisture ingress and potential for deterioration of the wood components.
- o Exploratory opening was conducted at the location where moisture content reading was 29.6%. Exp observed the sheathing to be soft showing evidence of moisture.
- o Exp observed a portion of the exterior wall assembly and a window was replaced / repaired at the semi-protected east elevation wall. We understand that this repair was conducted to address a localized water ingress issue. See Photos 01 and 02.

Photo 1: Unit 206 – Appears a localized rehabilitation of the exterior wall and window was conducted

Based on the moisture content readings and the exploratory opening, it is our opinion that the east elevation wall under EIFS band overhang also is experiencing moisture ingress and has potential for deterioration of wood components. While we note the damage may not be severe at this time, it is our opinion that replacement of this portion of the exterior wall is prudent considering the cost savings and reduced risks.

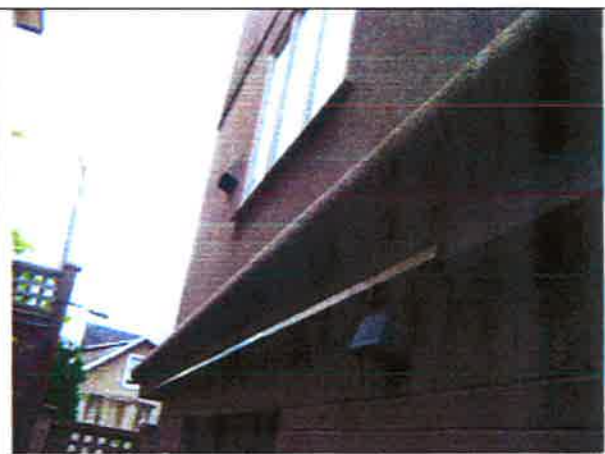
Photo 2: Unit 206 – Localized rehabilitation of the EIFS band

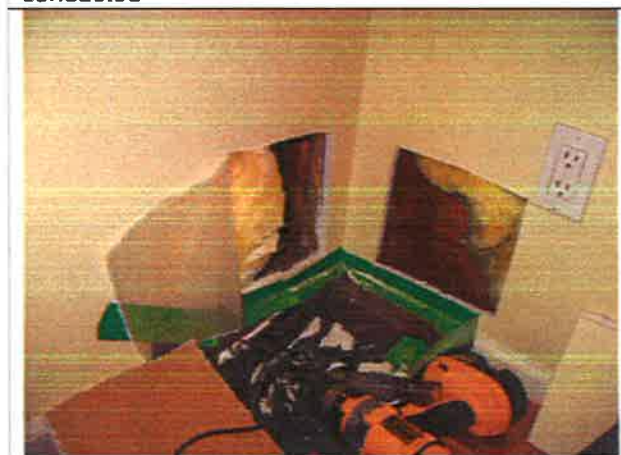
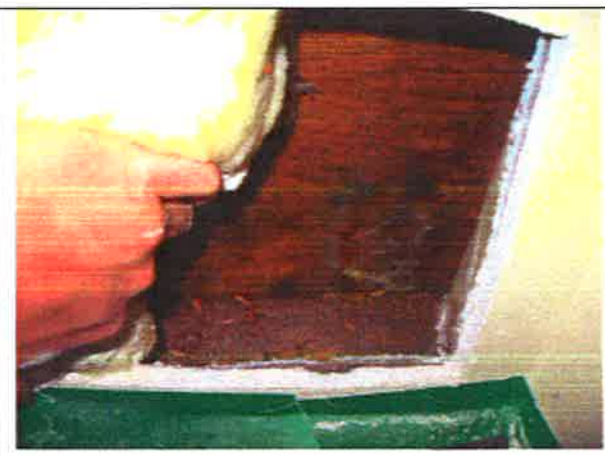
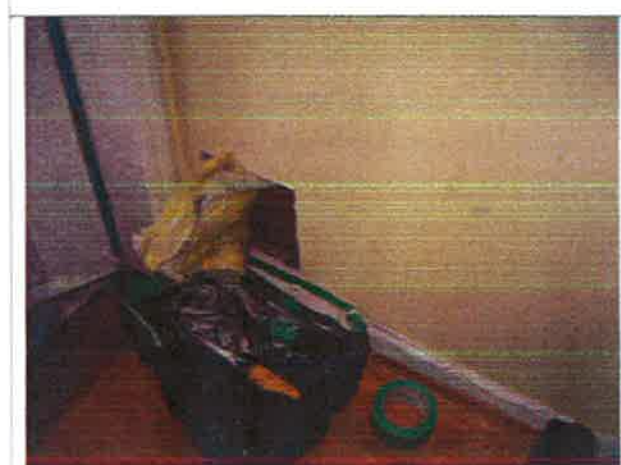
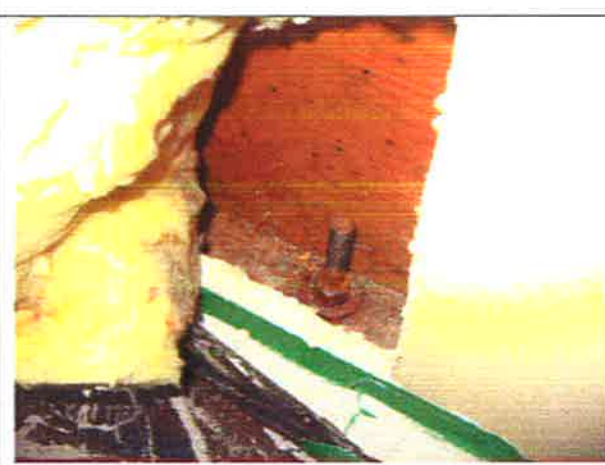
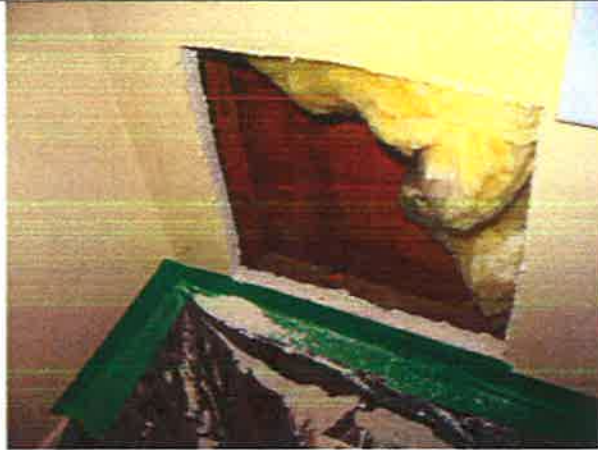
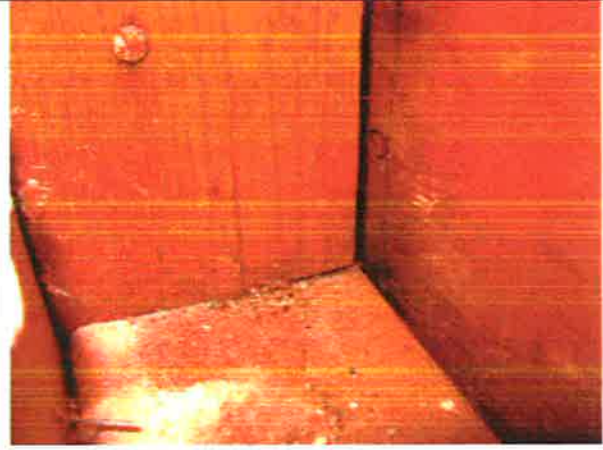
Based on the interior exploratory openings at Units 103, 105 and 108, it is our opinion that water ingress is not being experienced at the base of wall detail where the sandwich slab assembly intersects the podium slab detail. It appeared the base plate of the structural frame was anchored to the sandwich assembly as detailed. The condition of the wood frame structure at the reviewed locations was dry. See Photos 03 to 08.

Photo 3: Unit 103 – Interior exploratory opening

Photo 4: Unit 103 – Interior exploratory opening

Photo 5: Unit 105 – Interior exploratory opening

Photo 6: Unit 105 – Interior exploratory opening

Photo 7: Unit 108 – Interior exploratory opening

Photo 8: Unit 108 – Interior exploratory opening

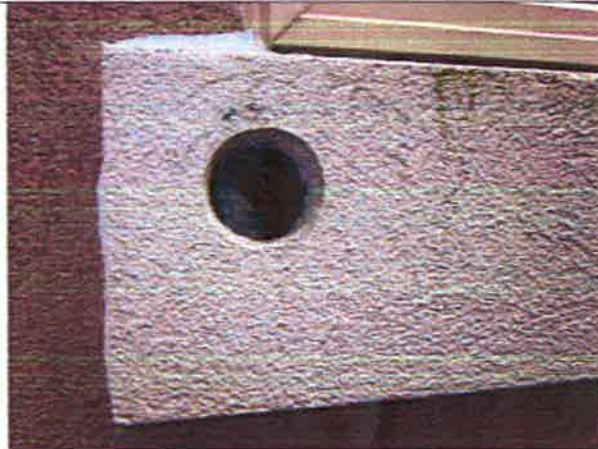
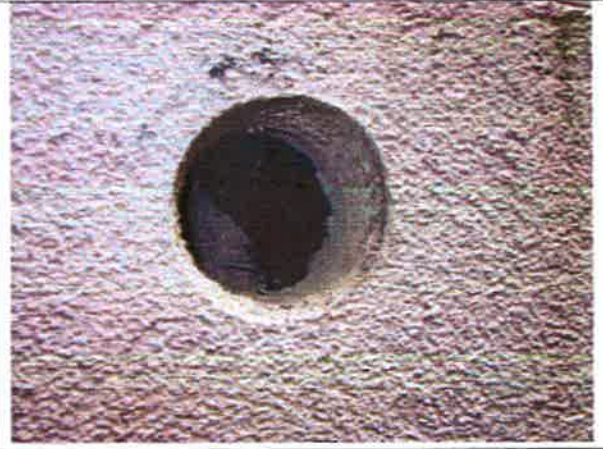
Exp conducted moisture probe readings through the EIFS band below the window sill to confirm the performance. Two out of 4 readings were observed above 19% MC. However, we believe the high moisture content readings are due to the high exposure in the east elevation combined with possible deficient details at the window interfaces rather than the problems with the EIFS band itself. See Photos 09 and 10. EIFS band was observed wet showing water retention, but observed no damage to the inner components of the exterior wall assembly. It is our opinion that remedial measures at this point are not warranted at this time.

Photo 9: Exploratory Opening at the EIFS below window sill in the east elevation

Photo 10: Exploratory Opening at the EIFS below window sill in the east elevation

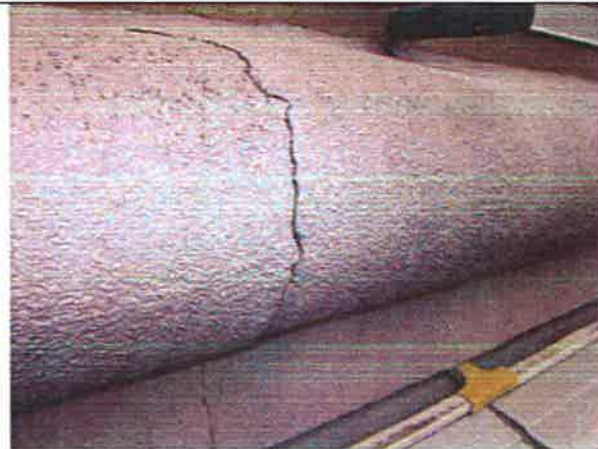
Exp conducted exploratory openings and moisture content readings through the large EIFS bands between Level 1 and 2 at a crack location. See Photos 11 and 12. Moisture content readings were also conducted through the brick veneer exterior wall assembly below the EIFS band. Exp observed all 3 moisture content readings conducted in this assembly were below 19% and the exploratory opening conducted showed no evidence of moisture. The detail as designed per the design documents is low performing and has potential for failure. The detail predominantly relies on the sealant joint between the EIFS band and the brick veneer. Exp recommends monitoring the condition and reporting any evidence of water ingress through this assembly for further investigation and potential replacement of the band with proper detailing. Such measure at this point of time is not warranted based on our review.

Photo 11: Crack in the EIFS band

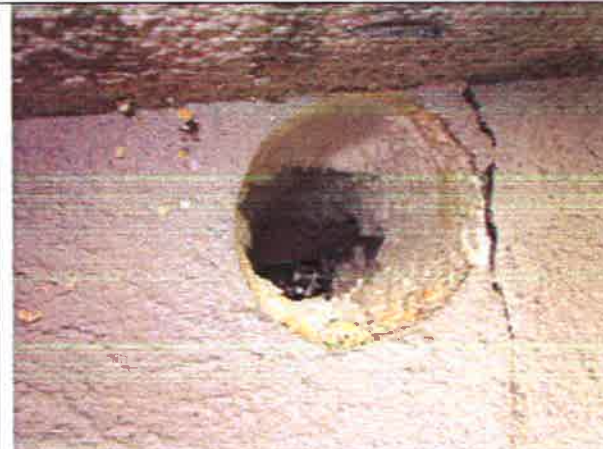
Photo 12: Exploratory opening adjacent to the crack in the EIFS band

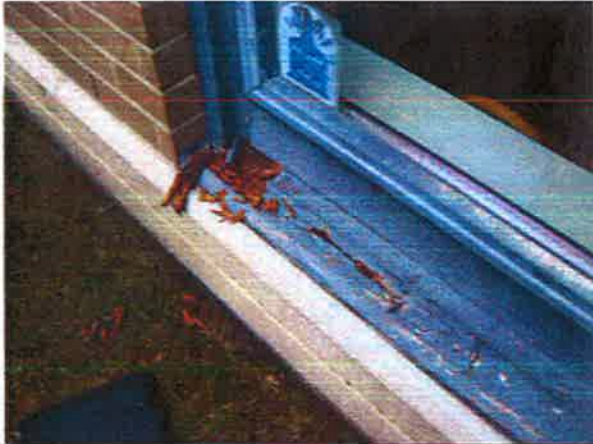
Exp observed the exterior wood trims (horizontal and vertical) at the window sill of the brick veneer wall assembly on Level 1 at random locations was deteriorated. Exp conducted exploratory openings by removing a portion of the deteriorated wood trim and observed self adhered membrane installed over a flashing that bridges between the gap between the inner wythe and the brick veneer cladding. See Photos 13 and 14. The self adhered membrane was installed over the metal flashing. We note the detail as observed was not per the similar detail WD-05 in the details package. The installed detail appears to provide adequate weather seal and does not warrant remedial measure by removing the window. We recommend replacement of the deteriorated wood trim as required and recommend a sheet metal flashing be installed

Photo 13: Deteriorated wood condition at the window sill of the brick veneer cladding

at the sill for longer durability. Exp recommends further review of the condition at the time of the wood trim replacement and conduct remedial work as required.

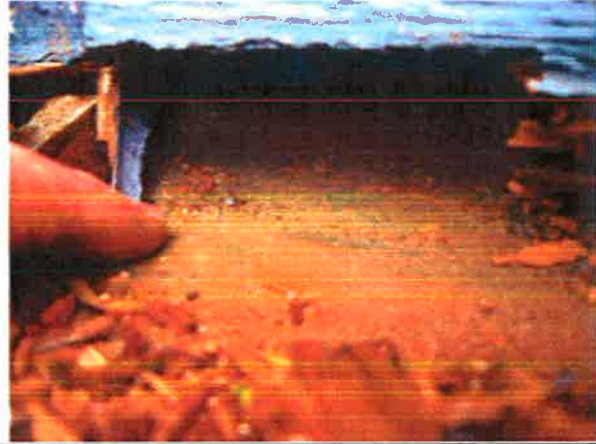
Photo 14: Membrane upturn and tie-in at the window sill over a metal flashing below deteriorated wood trim

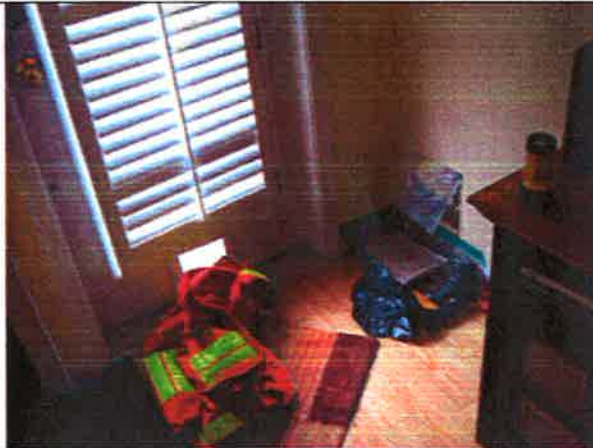
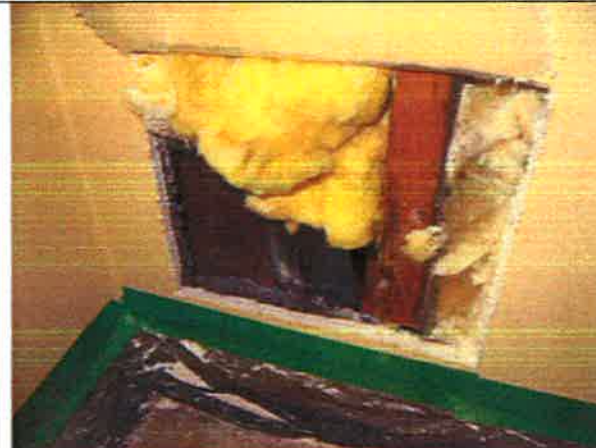
Exp observed the balcony deck drains are being routed through the exterior wall assembly per architectural drawings and on-site visual review. Exp conducted exploratory openings to confirm the systemic performance of these drains, e.g. condensation or water leaks. Based on our review at Unit 108 the drains within the exterior wall assemblies do not appear to have any systemic problems. See Photos 15 and 16.

Photo 15: Unit 108 - Interior exploratory opening to review the drain in the exterior wall

Photo 16: Unit 108 - Interior exploratory opening to review the drain in the exterior wall

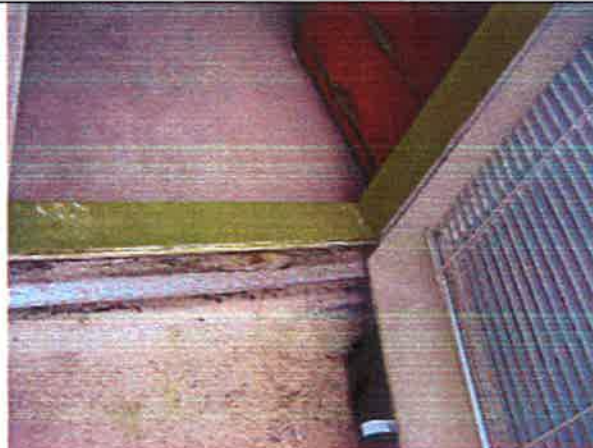
Per request from the Unit Owner of Unit 308, Exp reviewed the balcony deck. Exp observed deteriorated wood frame of the swing door assembly. Exp observed damage in the balcony deck membrane. Exp observed extensive staining in the trough at the balcony deck edge that is installed to drain water. See Photos 17 to 20. We note the replacement of the deck membrane and wood swing door is being conducted as part of the rehabilitation work per RDH report. We agree to the recommended measures of replacing the balcony deck membrane and wood swing doors per RDH report, based on our observations. In regards to the extensive staining in the trough, exp recommends a modification to eliminate the trough.

Photo 17: Unit 306 - Evidence of water ingress and deteriorated wood frame of the swing door

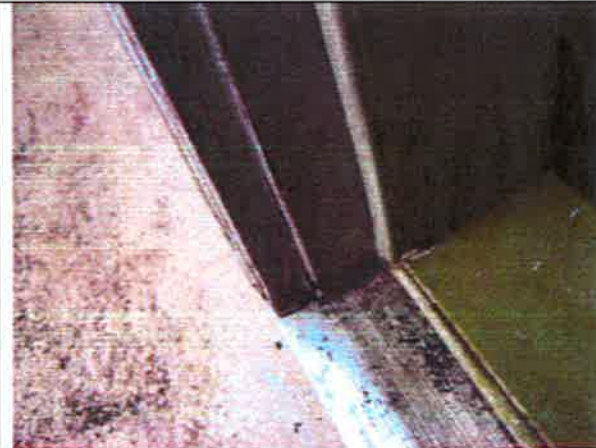
Photo 18: Unit 306 - Deteriorated wood frame of the swing door

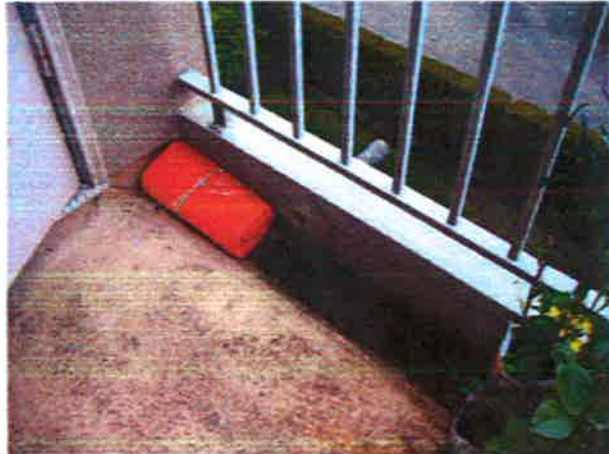
Photo 19: Unit 306 – Extensive staining at the tough of the balcony deck

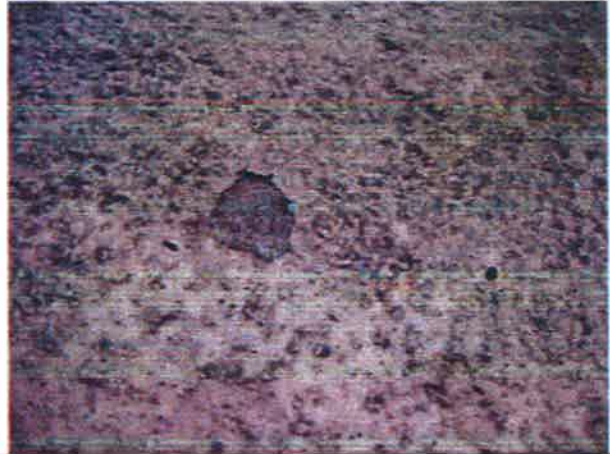
Photo 20: Unit 306 – Cracked and delaminated balcony deck membrane

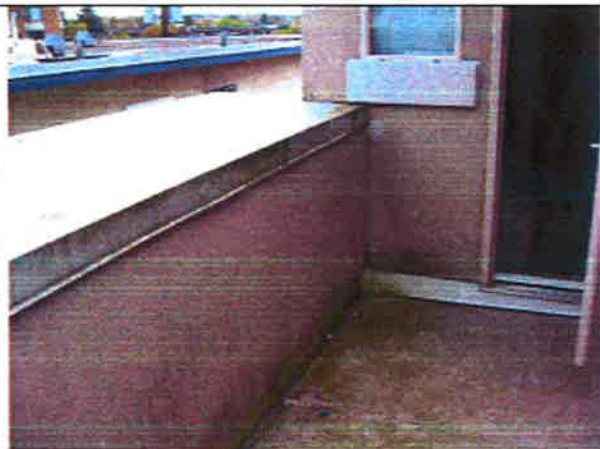
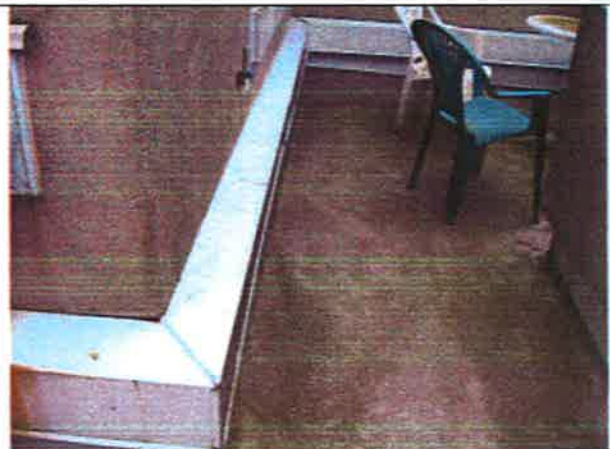
Exp conducted a visual review of the roof deck and the exterior wall of the bathroom of the amenity unit. We note the existing vinyl deck membrane at the roof deck of the amenity unit is not the preferred membrane for the assembly. However, no significant problems have been reported in the RDH report. Apart from the extensive staining in the deck membrane and exterior cladding of the parapet wall assembly, exp did not notice any significant performance issues. Exp observed exploratory openings and moisture content readings were conducted by RDH at the staining locations. See Photos 21 to 24. Moisture damage is not reported. Exp recommends monitoring the performance of the roof deck membrane and replace it at the end of the service life. Exp recommends installing more durable membrane. In regards to the exterior wall of the bathroom, exp didn't observe any evidence of damage. We note that this bathroom is expected to be sparsely used and hence reduced potential for damage. If the exterior wall assembly (east wall below EIFS overhang) from exterior will be rehabilitated, exp recommends to review the condition of the wood components and

Photo 21: Amenity Unit - Vinyl deck membrane with staining

Photo 22: Amenity Unit - Vinyl deck membrane with staining

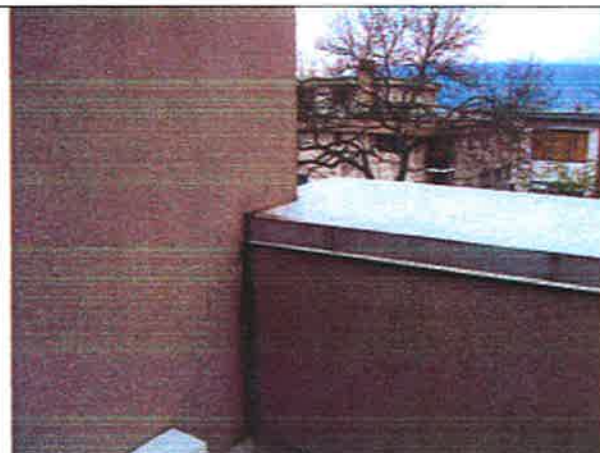
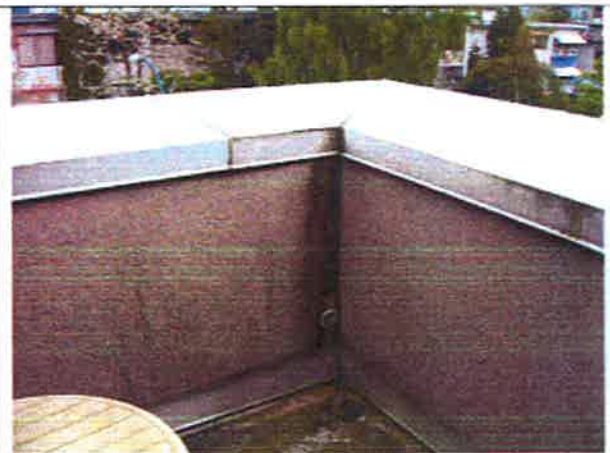
Photo 23: Amenity unit – Extensive staining of the parapet cladding at saddle and exploratory opening from earlier investigation

Photo 24: Amenity Unit – Extensive staining of the parapet cladding at saddle and exploratory opening from earlier investigation

the poly vapor barrier for evidence of damage. It is not warranted to conduct openings at this time.
